# Manhole Inspection Summary

Manhole # S37S\_\_003MH

**Inspection** ☐ Is Incomplete Rating: **3) Fair**

Insp Date: **2/19/08 1:56 PM**

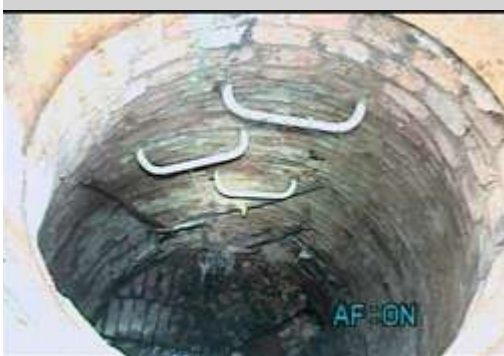
Defect 3

**Steps** Count: **5** Missing: **0** ☒ **Corroded**

steps corrosion

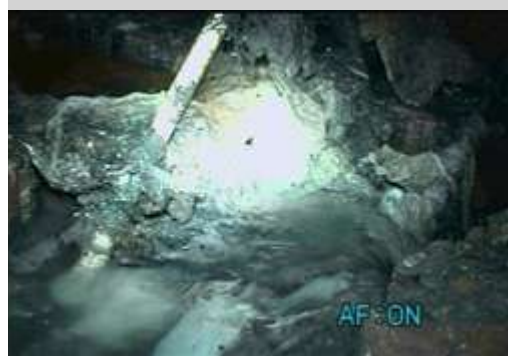
Defect 2

channel debris

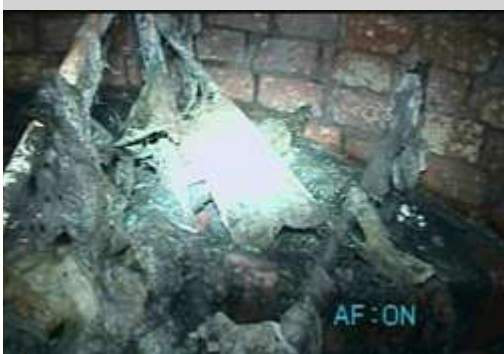
Defect 1

bench debris

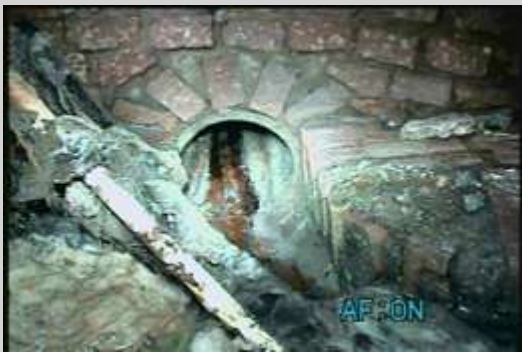
12 O'Clock Outflow

8 in. Circular Gravity Sewer  
Pipe Out @ 12 O'Clock

Pipe Height: (in.) Direct  
Pipe Material: **Clay** ☐ Pipe Lined  
Invert Depth: **9.50** (ft.) Flow Characteristics: **Fast**  
Deposits: ☐ None ☐ Mud ☐ Sludge ☒ **Debris** ☐ Grease  
Silt Depth: **1** (in.) Deposits Extent: **Light**  
Infiltration: **None** Pipe Seal Cond: **Unknown**

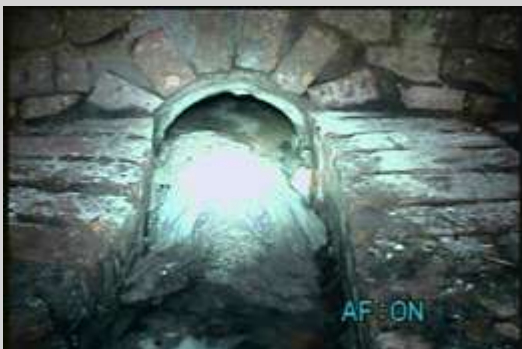
3 O'Clock Inflow

8 in. Circular Gravity Sewer  
Pipe In @ 3 O'Clock

Pipe Height: (in.) Direct  
Pipe Material: **Clay** ☐ Pipe Lined  
Invert Depth: **9.20** (ft.) Flow Characteristics: **Fast**  
Deposits: ☐ None ☐ Mud ☐ Sludge ☒ **Debris** ☐ Grease  
Silt Depth: **5** (in.) Deposits Extent: **Heavy**  
Infiltration: **None** Pipe Seal Cond: **Unknown**

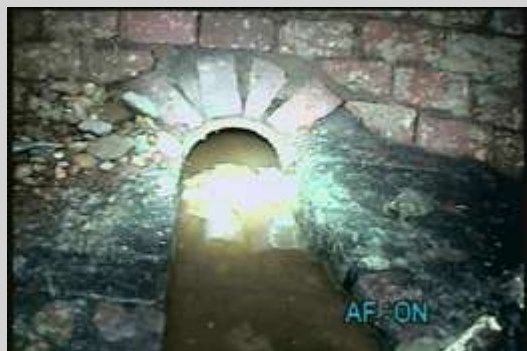
8 O'Clock Inflow

8 in. Circular Gravity Sewer  
Pipe In @ 8 O'Clock

Deposits: ☐ None ☐ Mud ☐ Sludge ☒ **Debris** ☐ Grease

Silt Depth: **3** (in.) Deposits Extent: **Heavy**
